FlashSeal[™]

*The Solution for Deteriorated
Flashings Around Chimneys,
Stack, and Vents*

ELASTOMERIC FLASHING SEALANT

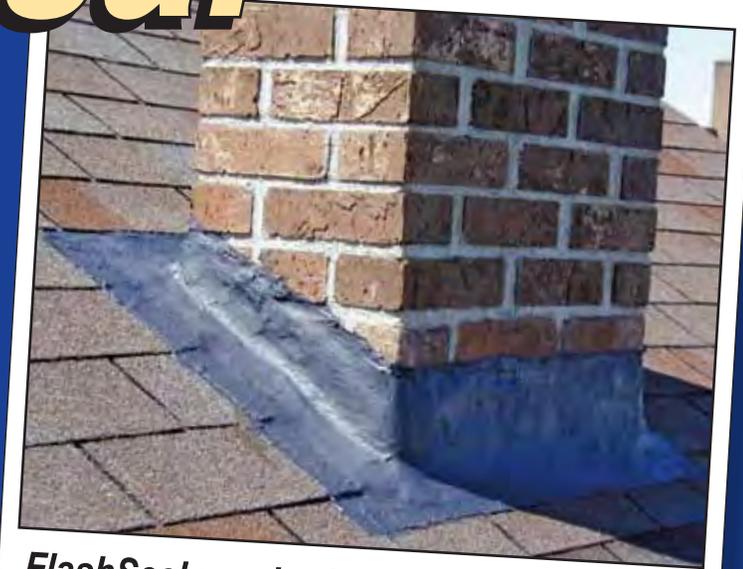
FlashSeal repairs faulty flashings around chimneys, stacks, and vents

A properly installed FlashSeal application is like installing a custom fit rubber boot around the base of your chimney. FlashSeal's strength and flexibility will provide years of trouble free service to help stop the damaging effects of water that can enter your home from a faulty or deteriorated flashing system.

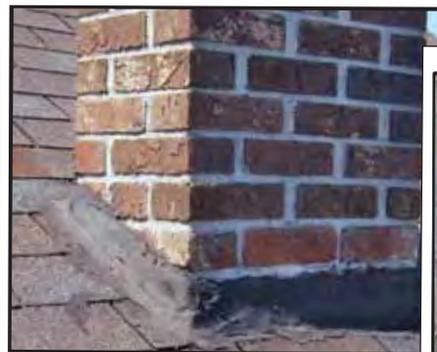
Chimney with cracked and deteriorated flashing

Flashing is the material at the base of chimneys, stacks and vents that is designed to waterproof the juncture where they penetrate the roof. Faulty or deteriorated flashings can cause leaks and water damage to the surrounding roof deck or eventually the interior finishes of your home.

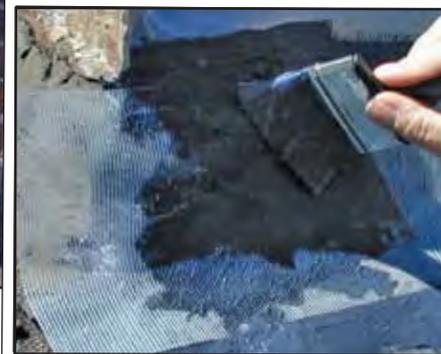
For added strength and flexibility, a fiberglass fabric is embedded between 2 coats of FlashSeal Elastomeric Sealant

FlashSeal Elastomeric Sealant is available in one gallon containers and is used in conjunction with FlashSeal Reinforcement Fabric sold separately in 150 ft. rolls. One roll of Reinforcement Fabric will last through 3 - 4 gallons of FlashSeal.

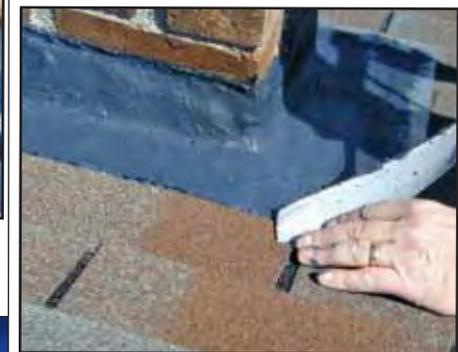
In most cases the roof deck and chimney are taped off to produce a neat appearance of the finished application
